HISTORIC PRESERVATION REVIEW BOARD STAFF REPORT AND RECOMMENDATION

Property Address: **513 U Street NW**
Landmark/District: **LeDroit Park Historic District**
ANC: **1B**

Meeting Date: **May 23, 2013**
H.P.A. Number: **#13-109**
Staff Reviewer: **Brendan Meyer**

The applicant, owners Quiton and Ritu Cooper, seek concept review for a partial third floor addition and penthouse, and other exterior alterations, to a two-story rowhouse at 513 U Street NW in the LeDroit Park Historic District. Plans were prepared by ABD, Inc.

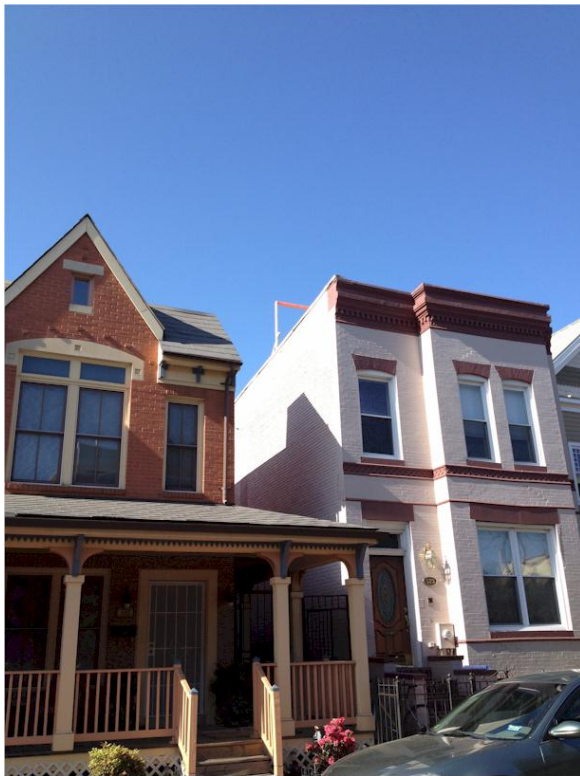
Figure 3. Flag test for third floor. Penthouse flag not erected.

The concept design has numerous deficiencies that make the proposed additions and alterations incompatible with the character of the historic district. Most significantly, the size of the additions, taken as a whole, is too large to fit on this relatively small rowhouse without resulting in substantially visible and incompatible changes to the roof of the house, roofline of the entire block, and the size and massing of the house in general. The detached condition of 513 U Street exposes the house to views not typical of a mid-block rowhouse. A flag test was erected by the applicant and inspected by staff.¹ While the addition was shown to not be visible from directly across the house, moving only a few feet in either direction along U Street brought the flag test quickly into view along the unattached sides of the house (Fig. 3).

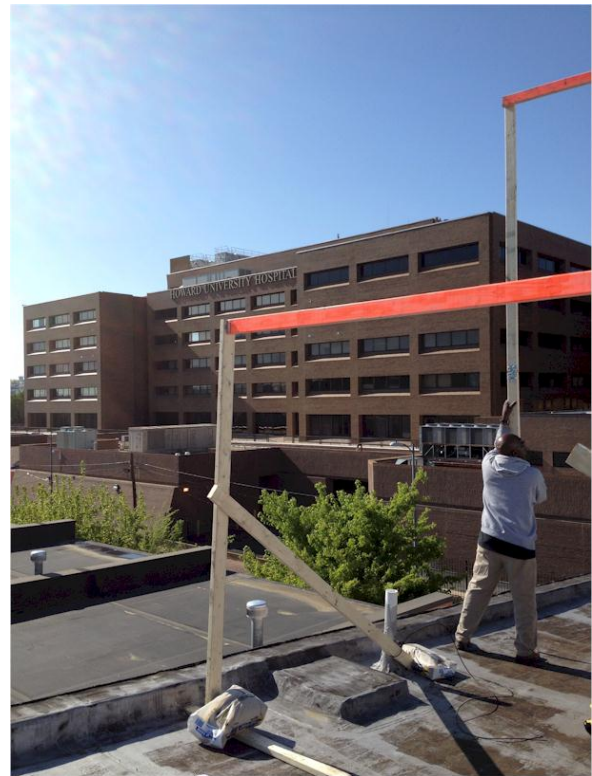
Figure 4. Third floor and penthouse flags.

¹ Street view photo shows only the proposed third floor roofline. For safety, the test for the penthouse was erected and held up by hand only briefly, but long enough for Staff to see that the penthouse would increase the visibility of the addition (Fig. 4).
